# Damages to the Façade of the Capanema Building caused by Thermal Action

Surveys carried out in the Gustavo Capanema Palace identified several pathologies that compromised the integrity of the façade and the flat slab in the Annex to the main building. Initially, the pathologies were evaluated and some criteria were established for performing the repairs of all identified damages. The pathologies were detected in the reinforced concrete structure and on the façade covered with granite stones. There were cracks on these granite stones and it was observed they were about to collapse. According to the analysis, the root cause of these pathologies was the thermal action because the building façade is composed of different materials and they behave differently when the temperature changes. The solution to eliminate this pathology was the execution of expansion joints, thus allowing the expansion of the materials without damaging the structure.

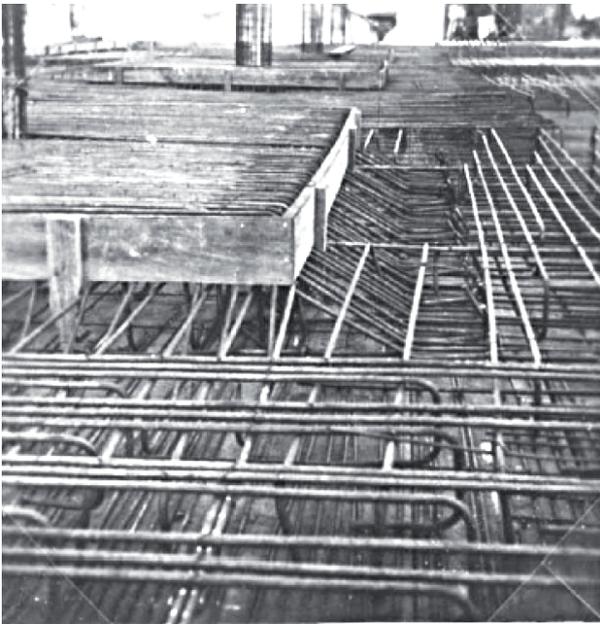
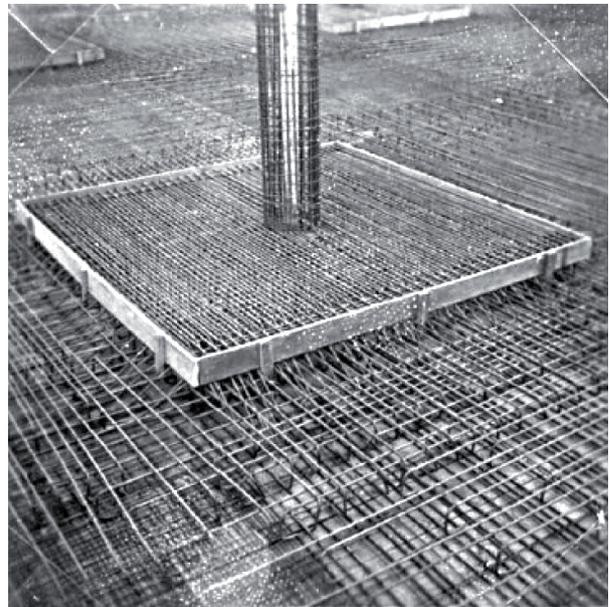
The structure of this Annex is peculiar. There is a mushroom slab with 32 cm of width and the capitals are inverted (Figure 1); on the slab there is a garden designed by Burle Marx. Between the capitals there is a filling of ceramic bricks, waterproofing sheets, earth and Portuguese pavement stones with a total width of 34 cm. A crack was found in the cladding stones and another horizontal one on the sides of the Annex but there were no displacements in the façade plane.

**Figure 1** – Inverted capital of the mushroom slab in the Annex (JERMANN, 2013):  
a) shapes and hooks of the folded bars; b) a suspension reinforcement.

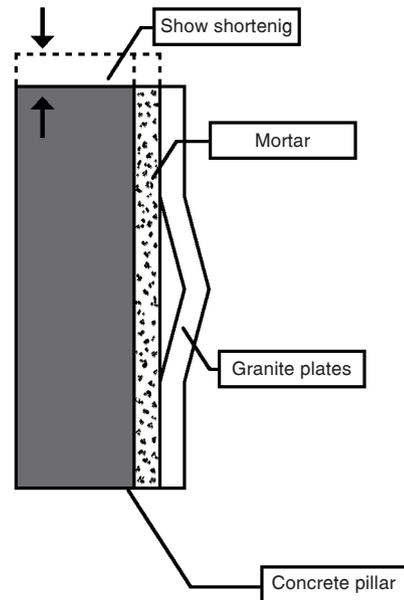
In order to confirm it, text presents the analysis of case that is similar to this one (THOMAZ, 2013), in which there are high levels of shearing stress in the stone mortar (Figure 2).

The root cause of the pathologies was the occurrence of high magnitude horizontal displacements in the slabs, but the cracks were formed in a similar way to that described in Thomaz (2013), which reports the following: 1) slow deformation and shrinkage due to concrete drying of the building columns is inevitable, and the mortar is subject to high tangential stress. As the stones do not have retraction or slow deformation, they do not go with the shortening of columns and thus remain compressed and buckled; 2) the thermal effect on the stones of the façade happens around 60 °C, and the stones tend to dilate differently from the reinforced concrete structure, causing stress similar to that of retraction and fluency.

**Figure 2** – Differential behavior of the materials in a façade with concrete substrate and granite coating (THOMAZ, 2013).

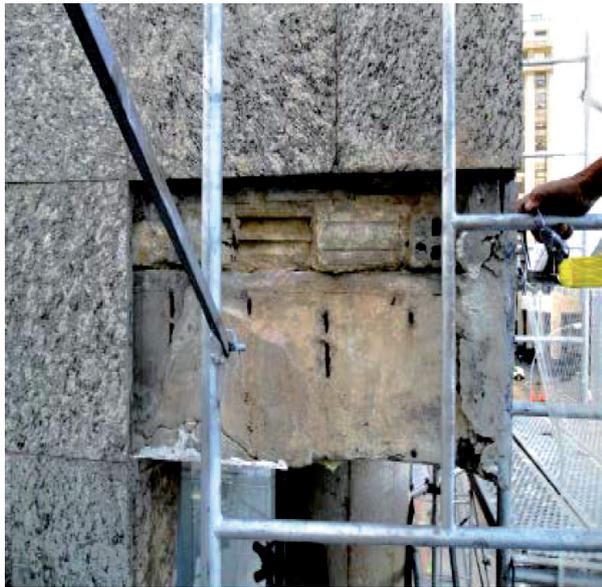
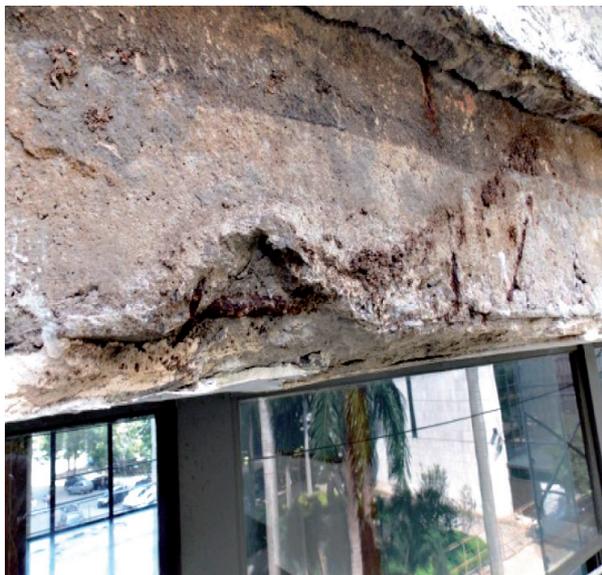
Regarding the pathologies on the blind wall (façade), control joints should be created in the external covering in order to prevent its collapse by assimilating the differential displacements of the materials and distributing these differences in sections of smaller dimensions (thus, smaller cracks). Figure 3 shows several elements that make up the façade and the damages

at the interface between the mushroom slab and the finishing stone.

**Figure 3** – Damages to the stones on the pilotis façade (FILLIZOLA, 2013): a) constituent elements of the façade; b) details of the edge of the mushroom slab with exposed reinforcement.

There was differential displacement between the slab and the ceramic brick filling:

- 1) coating plate made of stone;
- 2) ceramic brick filling layer made with a width of 34 cm;
- 3) reinforced concrete slab with a height of 32 cm.

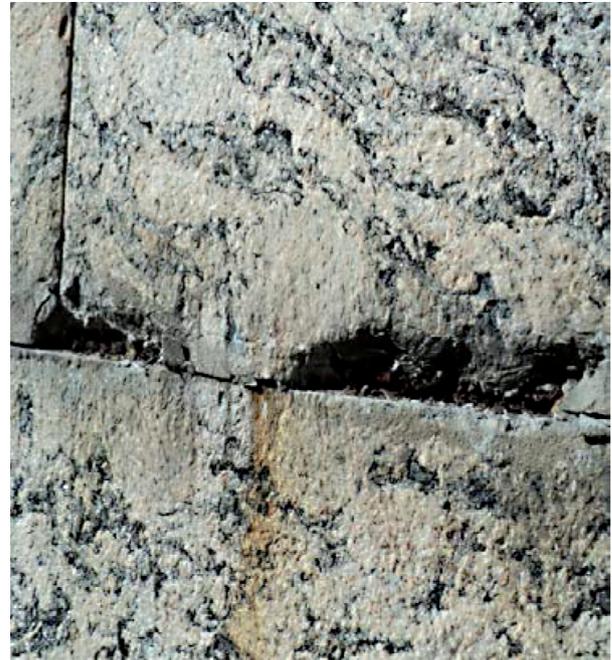
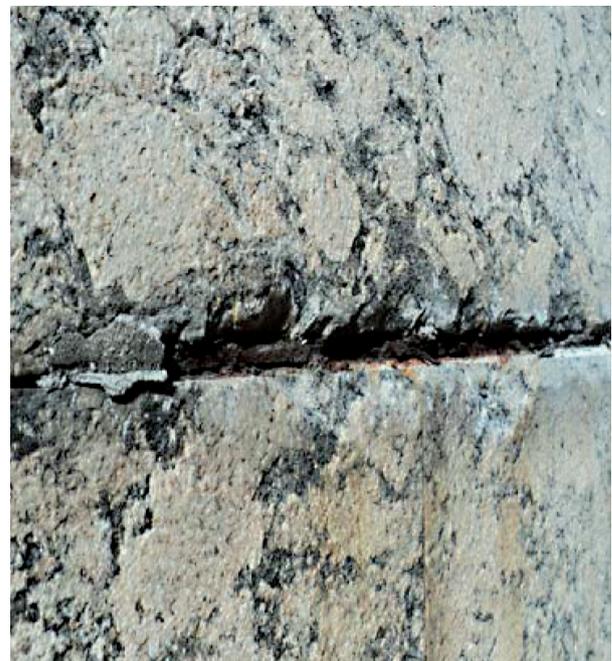
It was observed that the metallic element used to block the granite stones in the ceramic brick masonry platband was corroded (Figure 4). One factor that caused the corrosion was the moisture in the joint between the stones. These metal elements had no corrosion treatment.

**Figure 4** – Corrosion of the metal element used to block the stones: a) rust stain; b) metal insert (FILLIZOLA, 2013).

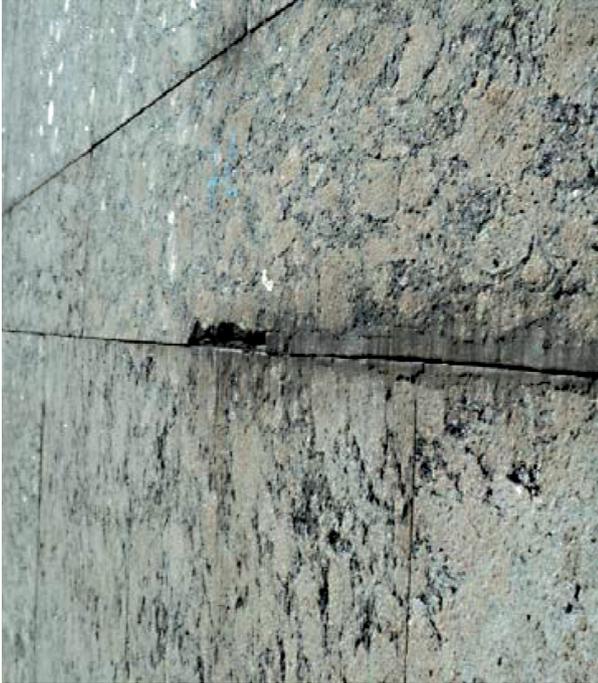
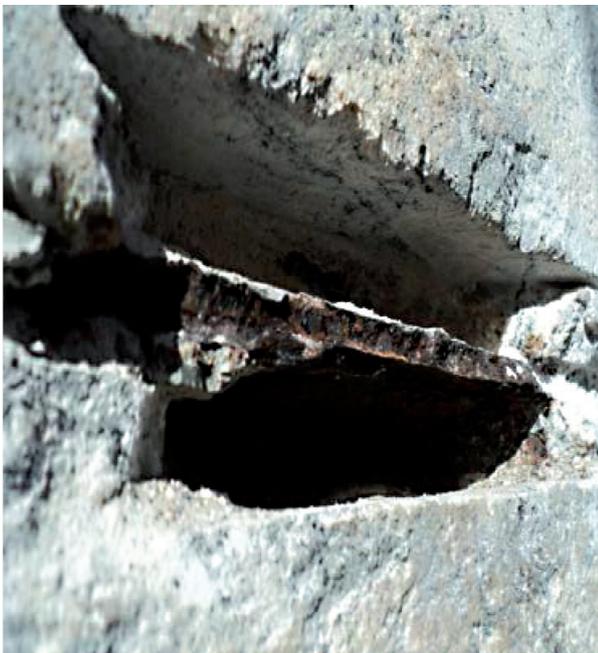
*Figure 5 – Removal of stones: a) dark color indicating moisture; b) removal of parts of the stained stones (FILLIZOLA, 2013).*

Figures 5 and 6, respectively, show the stains observed and the dimensions and depths of the insert. The removal of pieces from the stones was subsequently replaced with the same material, i.e., powder of the original granite from the surface, according to the prescriptions of Salles and Garros (2013).

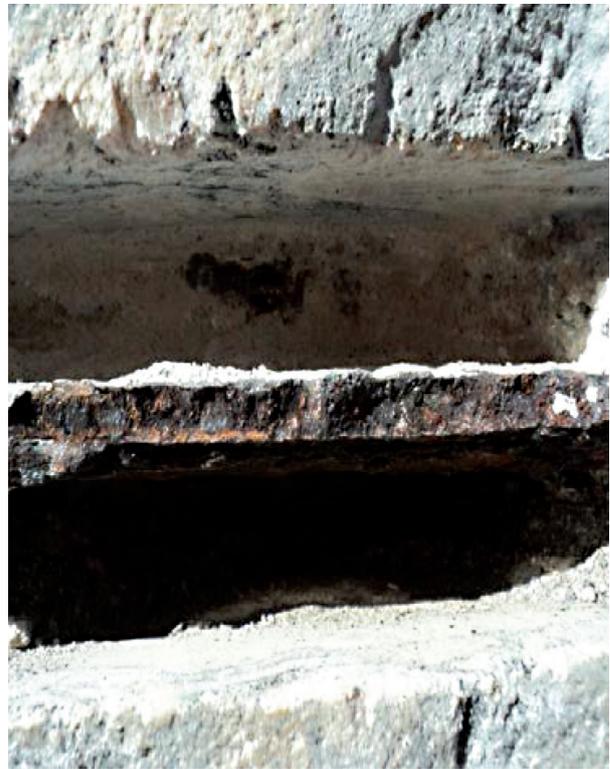
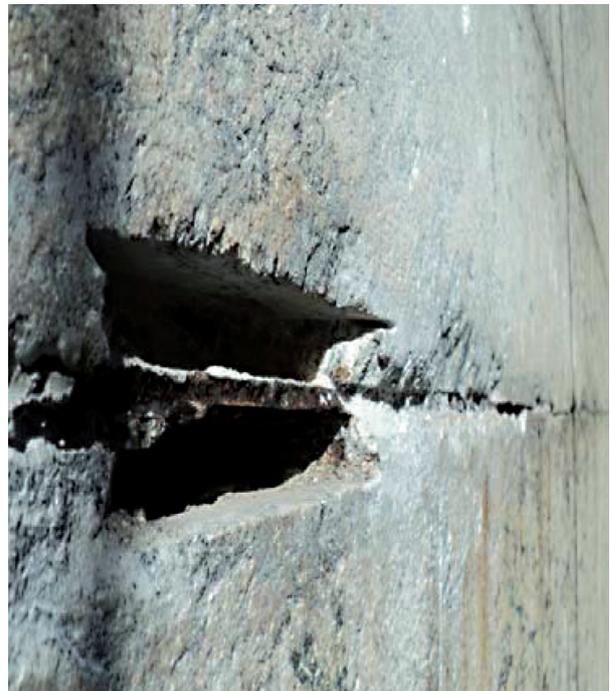
*Figure 6 – Corrosion of the metal element that blocks the stones: a) depth of the insert; b) exploration to verify the dimensions of the insert (FILLIZOLA, 2013).*

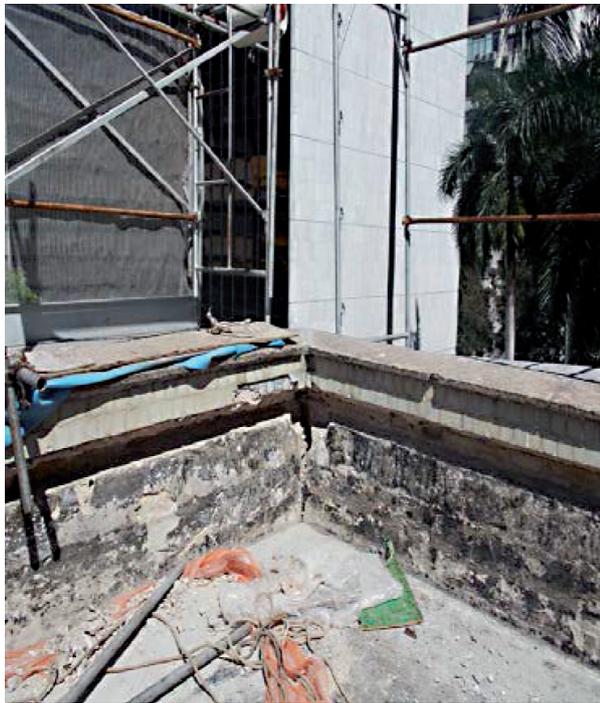
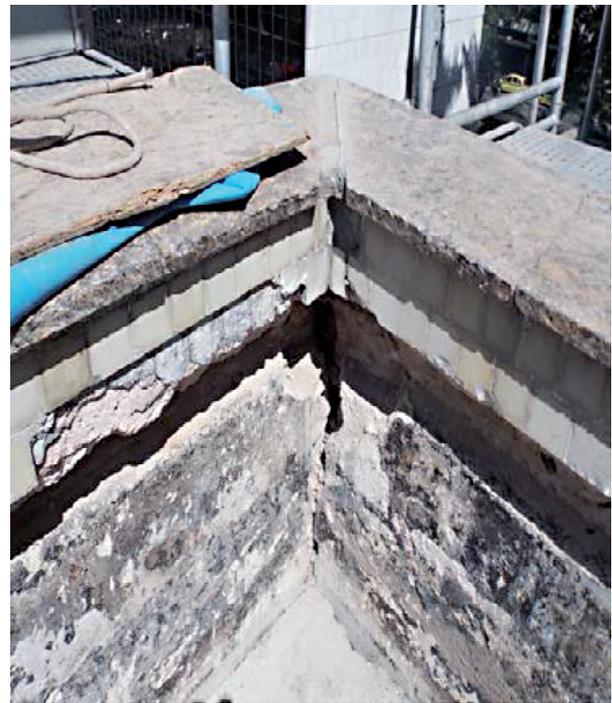
**Figure 7** – Cracked in the junction between the transverse and longitudinal walls:  
a) overview; b) detailed highlight of slit size (SÁNCHEZ FILHO, 2013).

also at the junction between the mushroom slab and the building tower. Some cracks appeared on the platband corners, evidencing the existence of differential displacements between the structure (mushroom slab with inverted capitals) and the masonry (Figure 7).

Control joints must be placed in the joints between materials of different elasticity modules (columns and masonry walls). Sealants with an expansion of 50% should be used to fill these joints. However, in the expansion joints a mastic-based sealant with an expansion of 25% was adopted because it requires a higher width (ASTM C1193 – 16, ASTM C920, ASTM – SPT 1069, NBR 6118:2014).

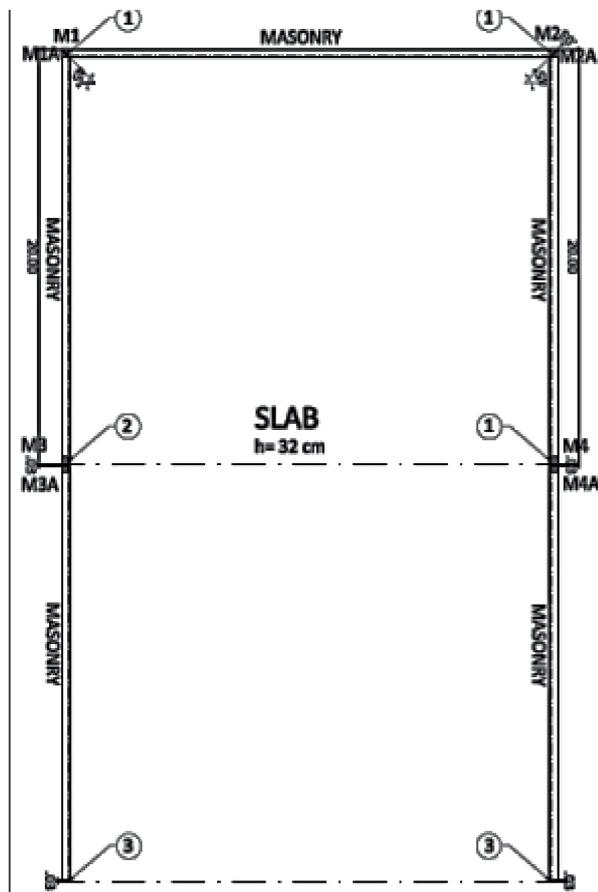
Figure 8 – Expansion joints designed (SÁNCHEZ FILHO, 2013).

The width value obtained for the expansion joint is high, thus using only one joint in the diagonal position of the joints between the transverse and longitudinal walls is unviable. The best option found was to apply three joints: one in the joint with the tower, another one in the middle of the longitudinal wall and the next one at the joint between this last-mentioned wall and the transverse wall. The sum of the widths of these joints was higher than 65 mm (Figure 8).

concrete mushroom slab and the masonry walls around it, the required joint width was designed. However, due to the large width value obtained from this process and considering that the Annex's length is higher than 40.00 m, three joints were created: the first one between the tower and the Annex; the second in the middle of the mushroom slab's length, and the last one in the joint between the longitudinal and transverse walls.
