Analysis of Pathological Manifestations in Grain Storage Steel Silo Foundations

A Grain storage silos, as well as other buildings, are susceptible to structural pathologies that can compromise their performance and reduce life cycle. The study of pathological manifestations in these constructions can contribute to prevent structural problems and accidents. This work shows the main pathological manifestations that appear in foundations of steel silos for grain storage. It analyzes characteristics such as design, flowchart, operation, and maintenance of silo foundations. The survey and analysis of pathological manifestations were conducted with the objective of identifying the most frequent causes of these problems. There was a high occurrence of settlements, which appeared in 62% of all constructions inspected. There were a significant number of cases of corrosion on reinforcement or on the union with the metal-based structure, found in 77% and 69% of units, respectively. There were concrete fissures and cracks in 38%, and other pathologies with lower incidence. A few recommendations are presented at the end of this work.

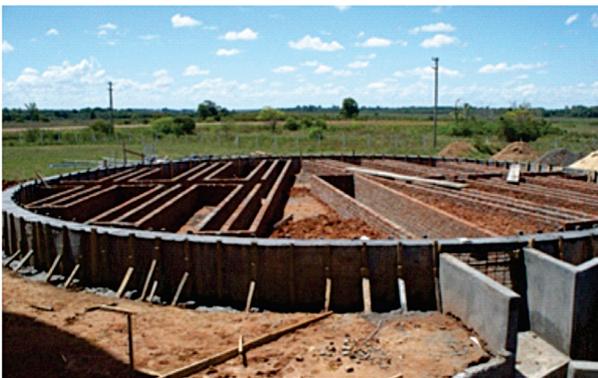
Figure 2 – (a) A circular-beam base during its construction; (b) Circular slab on the ground during construction.

cause tilting, differential settlement, and collapse. On western border of Rio Grande do Sul state there are two common types of silo bases. A circular-beam supported by piles or columns and a slab on the ground. Both systems need a slab on the ground to receive most of the grain load. The difference is that in a circular-beam system, steel walls are supported by a beam and not directly over a slab. Figure 2(a) shows a circular-beam base during its construction and Figure 2(b) shows a circular slab on the ground before placing concrete.

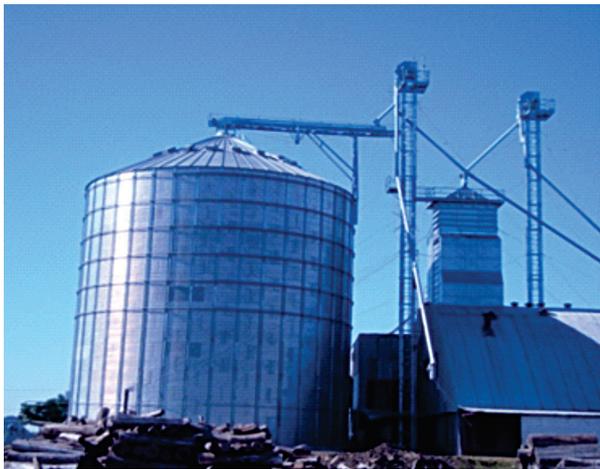
It can be observed, in Figure 4(a), that this silo suffered a great inclination caused by settlement of the base, behaving as a rigid body. According to Velloso and Lopes (2004), differential settlements are caused by a presence of regions of low-resistance ground. In this case, it is possible that during the construction of this base, the superficial organic layer of the soil was not completely removed, thus causing the settlement.

Figure 4 – (a) Settlement of the base; (b) Cracking caused by corrosion of reinforcement; (c) Corrosion at a joint between a concrete base and a metal wall; and (d) Biological agents on the base of the silo and sidewalk.

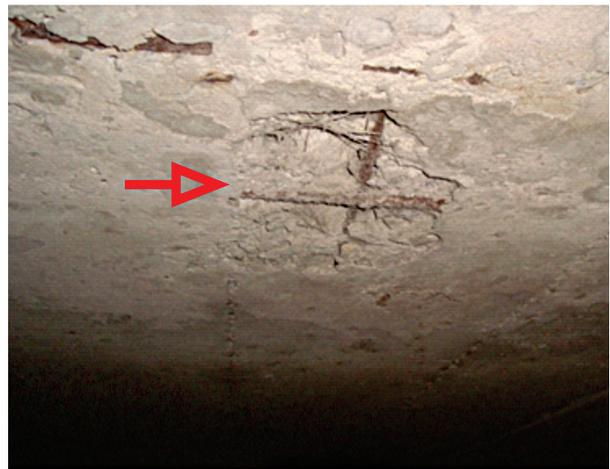
(b)

In 77% of these industries, we found cracks caused by corrosion of reinforcement. That was due to small concrete cover, high porosity, and presence of moisture. Figure 4(b) shows a corrosion crack observed.

This cracking is caused by steel oxidation, which produces hydrated iron oxide ($Fe_2O_3 \cdot nH_2O$) that occupies a volume greater than the original steel, which breaks the concrete cover and leaves the reinforcement exposed.

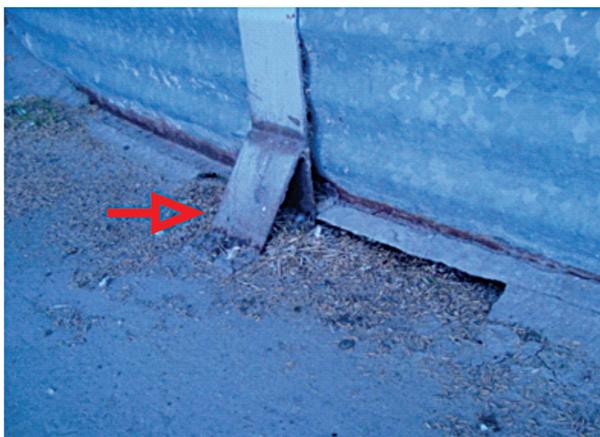
(c)

Corrosion was also observed in the union of concrete and steel walls in 69.2% of all bases inspected, caused by design problems and ineffective maintenance. Such conditions are common in regions with humid weather and lack of sun incidence. According to Ripper

and Souza (1998), corrosion on bolts and other metal parts embedded in concrete accelerate this process when they are not properly protected with oil or anti-corrosive products. Figure 4(c) shows a point of corrosion at a joint between a steel wall and a concrete base.

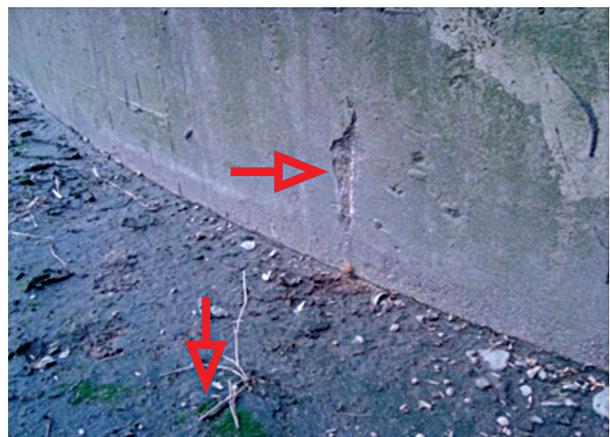
(d)

Biological agents were found in 76.9% of all units inspected. It is possible that this has been caused by accumulating a lot of dust, seed remains, and moisture, thus being an ideal place for growing fungi, bacteria, and vegetation, in addition to the presence of rodents and other pests.

Figure 4(d) shows a silo base without a sidewalk to protect its structure, and its beam in direct contact with the ground. This forms a layer of lichens and fungi at the surface of concrete, damaging its appearance and creating organic and inorganic acids that can attack it, in addition to accumulating moisture that can promote corrosion of reinforcement, Palermo *et al.* (1997), cited by Hausenstein (2009).

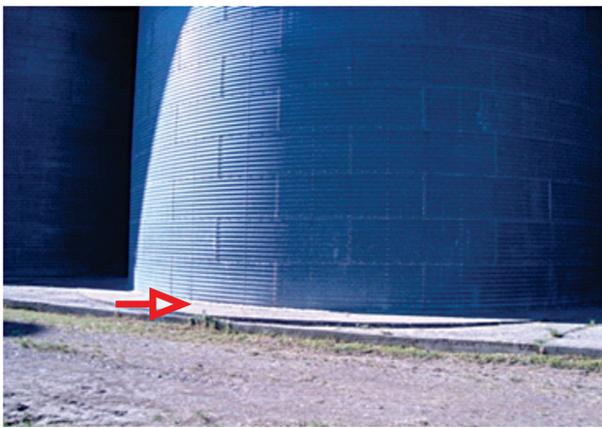
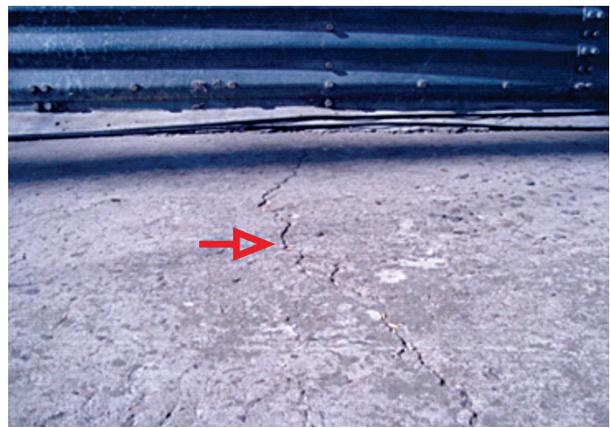
Cracking caused by thermal movement were observed in 53.8% of all industries (Figures 5 (a) and (b)). It was found in slabs on the ground bases, widely used in this region of the state. These bases are characterized by a flat slab with a thickness ranging from 15 to 30 cm. Souza and Ripper (1998) attribute this type of cracking to the existing temperature gradient between different regions of the structure, resulting in the appearance of natural concrete joints. In the case of foundation slabs, the temperature gradient is between the upper face, exposed to direct sunlight, and the lower face in contact with the ground.

In this case, the pathological manifestation can be attributed to the large area exposed to direct sunlight, because the circular concrete slab extends beyond the contour of silo's metal wall. It can be noticed that these

cracks are approximately spaced evenly and usually appear on the west side, where the sun is more intense in the summer, as it is the case of the region studied.

Figure 5 – (a) Cracks caused by thermal movement- slab on the ground under sun incidence; (b) Crack observed caused by thermal movement; (c) Excessive deformation at the span of a discharge tunnel; (d) Reinforced concrete wall with a crack at 45°; (e) Cracks caused by wind stress in anchor stretch; and (f) Cracks caused by wind stress.

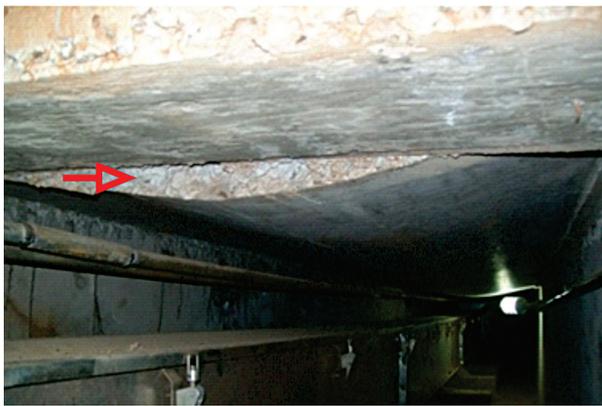
(c)

Excessive deformation appears in 46.2% of all units inspected. It was observed, as shown in Figure 5(c), in some concrete bases built with circular-beam over piles, deformations above the limits established by Brazilian Code NBR 6118 (2003) at the span of the discharge tunnel.

There are some possibilities for this problem: wrong considerations during design, mistakes in loading, which is not acceptable since these loads are provided by the silo manufacturer, or construction mistakes using wrong thickness or wrong reinforcement.

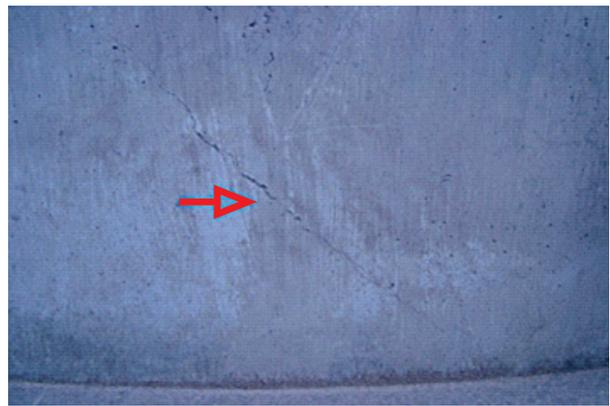
(d)

As seen on Figure 5(d), the silo's reinforced concrete wall presents cracks at 45°, characterizing a structural failure.

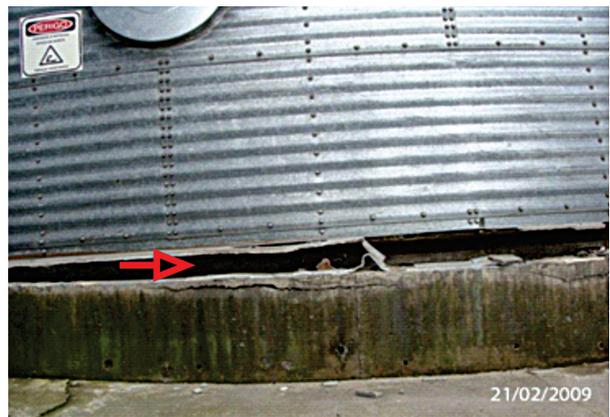
Cracks caused by wind stress were observed in 38.5% of all industries analyzed. In some bases, wind action resulted in cracking. In others, anchor stretches were observed. Figures 5 (e) and (f) give an example of wind action. In all wind problem cases, cracks are located near to anchors, since these are responsible for transmitting tension from steel walls to the concrete structure.

The authors had access to steel structure designs of some Brazilian manufacturers, and it was observed disrespect to national standardization. Lower wind speed and wind pressure than specified in NBR 6123 (1988) were adopted. Brazilian manufacturers adopted for this design a wind speed of 120 km/h, below the specified speed for this region of the country, which is 162 km/h.
